Austar Coal Mine

**Baseline Ecological Monitoring
Report for Stage 2 Longwalls,
Austar Mine, Quorrobolong**

June 2009

Project Director:	Peter Jamieson		
Project Manager:	Alaina Casey		
Report No.	2274/R32/V2/FINAL	Date:	June 2009

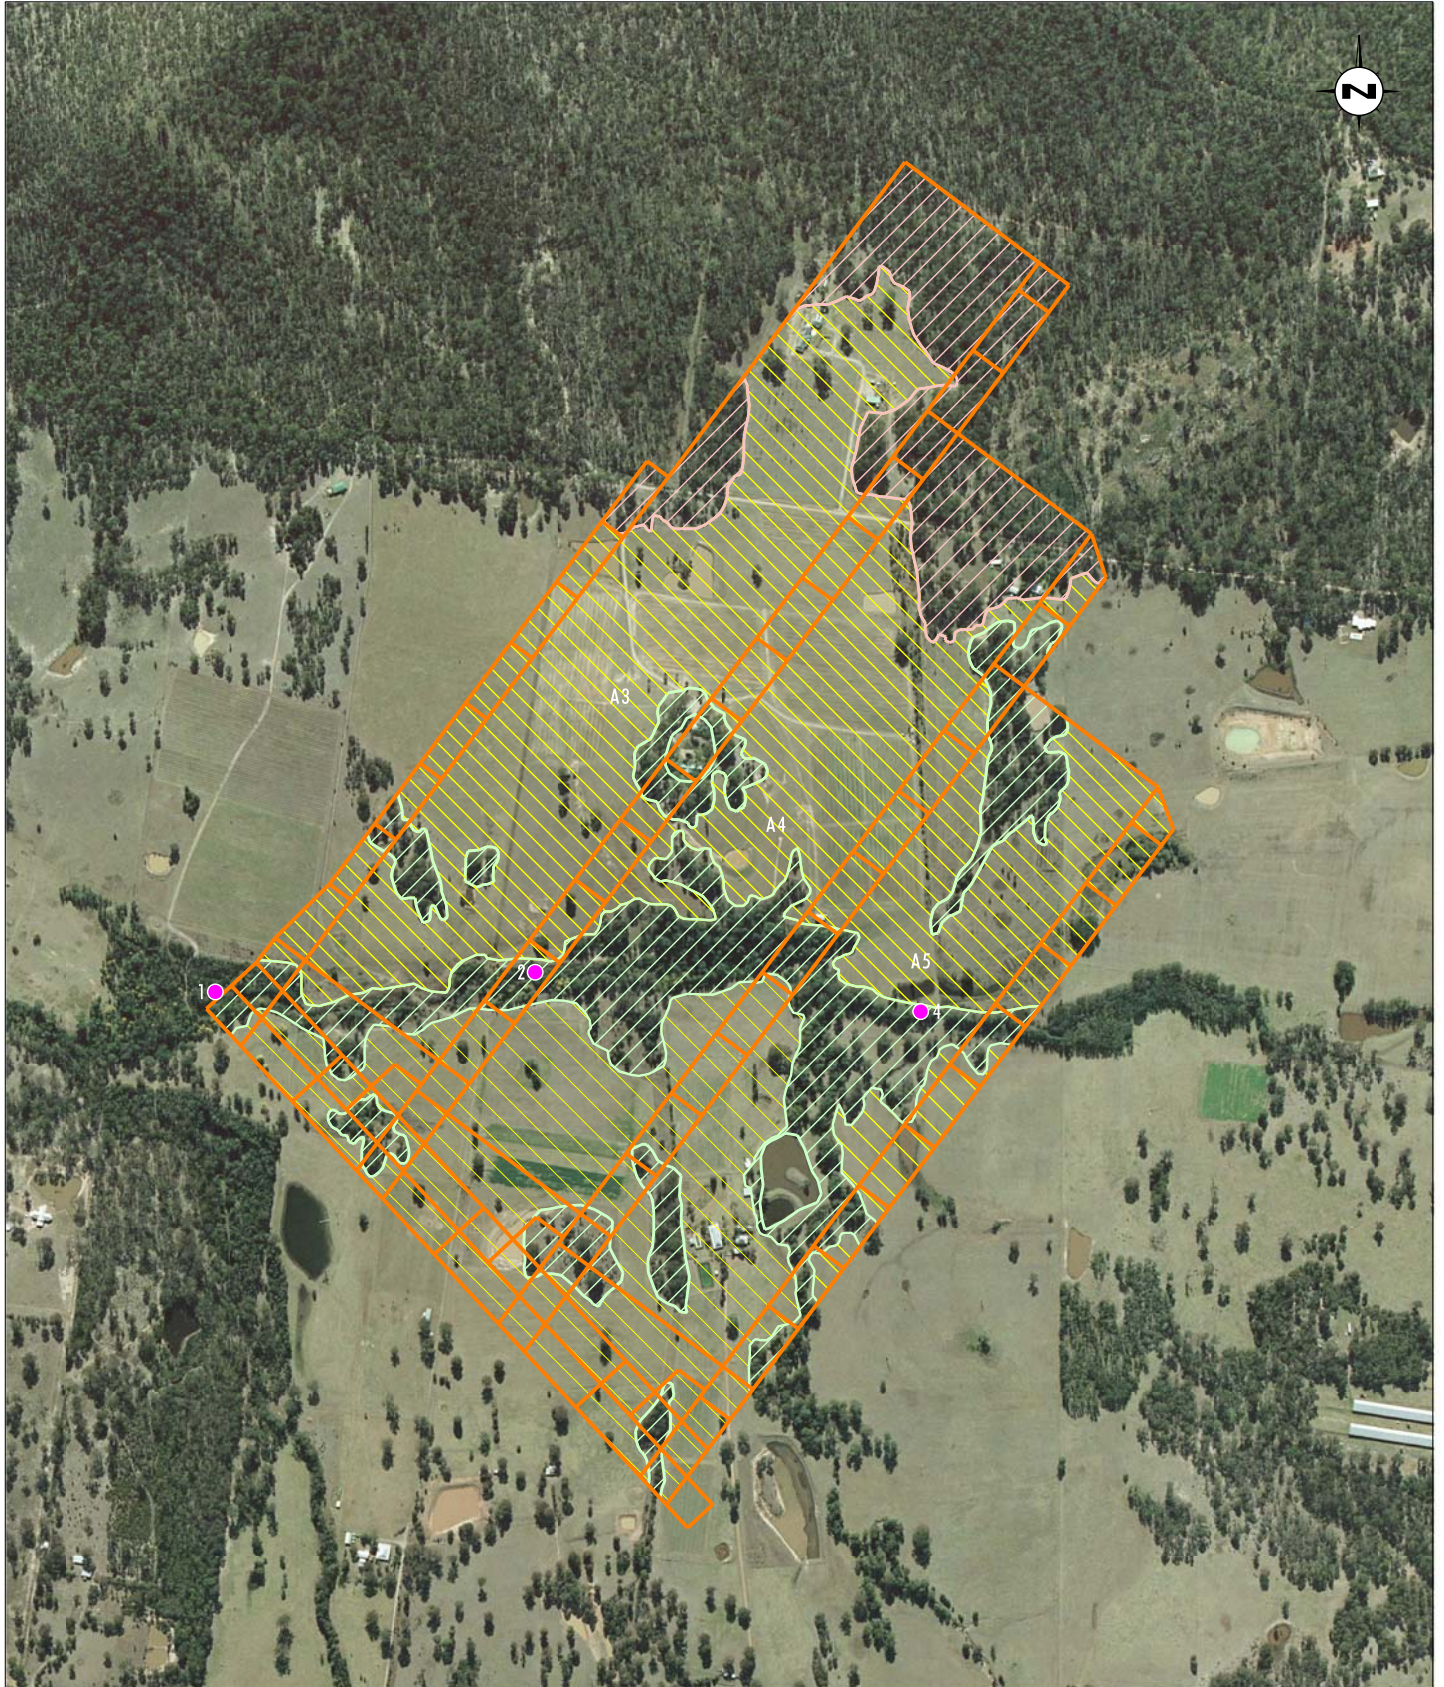
FIGURE 2.1

The locations of the two established vegetation sampling sites are marked on **Figure 2.1**. The MGA grid co-ordinates for each site are provided in **Appendix 1**.

Location of Monitoring Sites

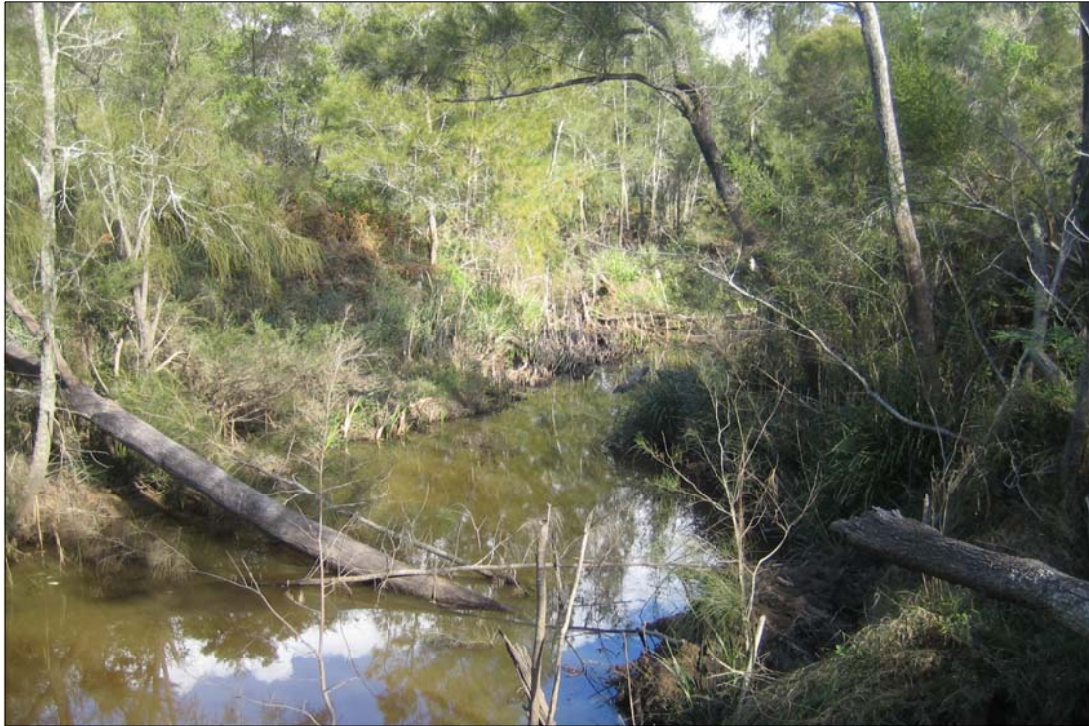
PLATE 1
Site 1 North Corner Bearing 180 Autumn

Significant bank slumping is present on the south bank of the creek at this location. This slumping is likely to be due to the lack of stabilising vegetation on this section of the bank.

Overall, the vegetation at Site 1 is relatively disturbed. It has a history of clearing and is currently threatened by weed species. Additionally, the bank is unstable, with areas of severe bank slumping evident. There is also low evidence of dieback in the canopy trees, which in some cases may indicate a tree's response to stress.

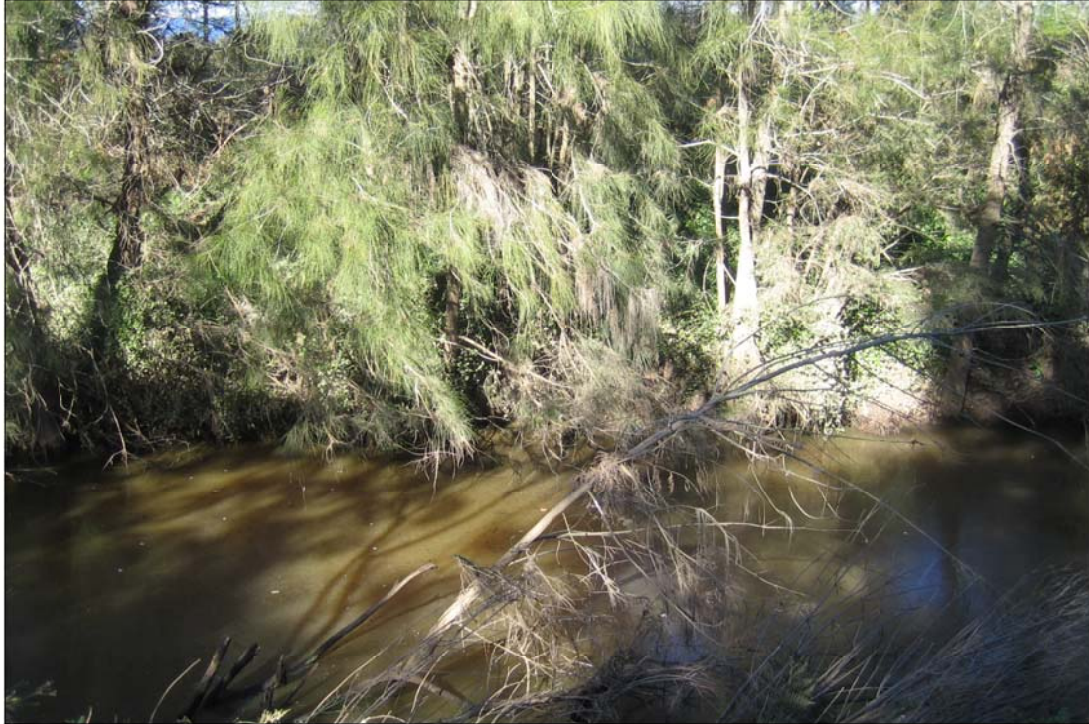
PLATE 3
Site 2 West Corner Bearing 180 Autumn 2008

There has been clearing of the riparian vegetation in the past with subsequent grazing. Consequently the current vegetation is in a state of regeneration, with few mature trees and simplified understorey structure and floristics. No evidence of crown dieback was observed at this site. Slight bank undercutting is present along this reach of the creek. This erosion is likely due to the lack of stabilising vegetation on the banks.

Overall, the vegetation at Site 2 is relatively disturbed. It has a history of clearing, and is currently threatened by introduced species. The bank is reasonably stable, however there is evidence of minor bank erosion/undercutting.

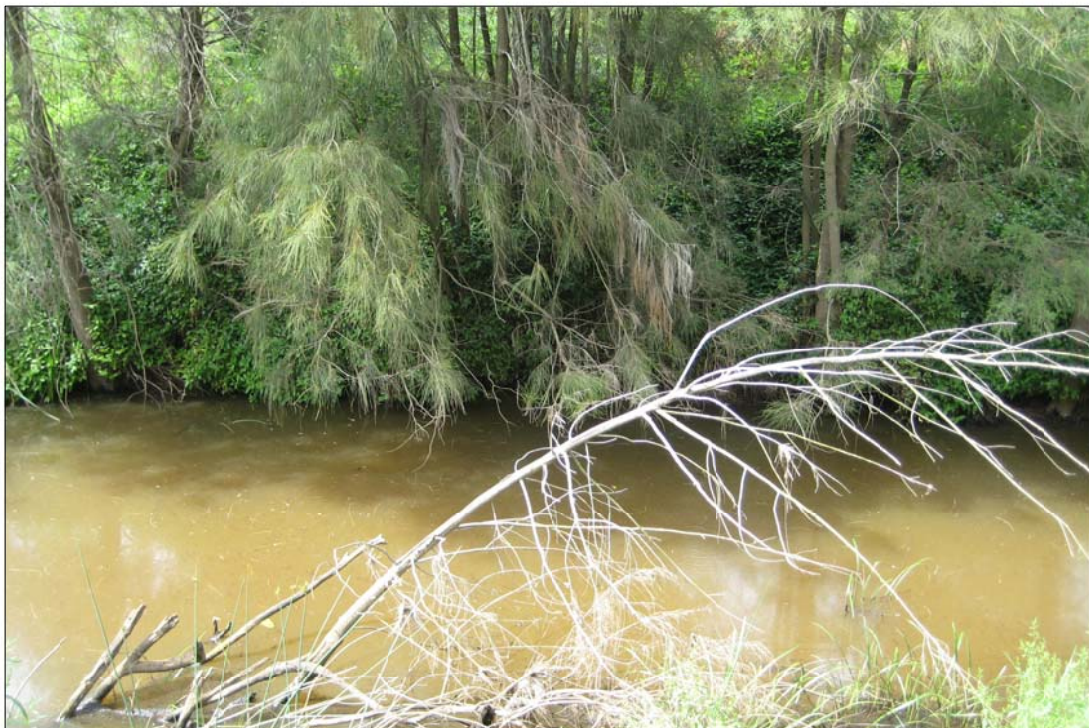
PLATE 4
Site 2 West Corner Bearing 180 Spring 2008

There was an increase in the density of weed species at Site 2 between the autumn and the spring 2008 surveys. In particular, wandering Jew (*Tradescantia fluminensis*) and blackberry (*Rubus fruticosus* sp. agg) both increased by approximately 10% cover.

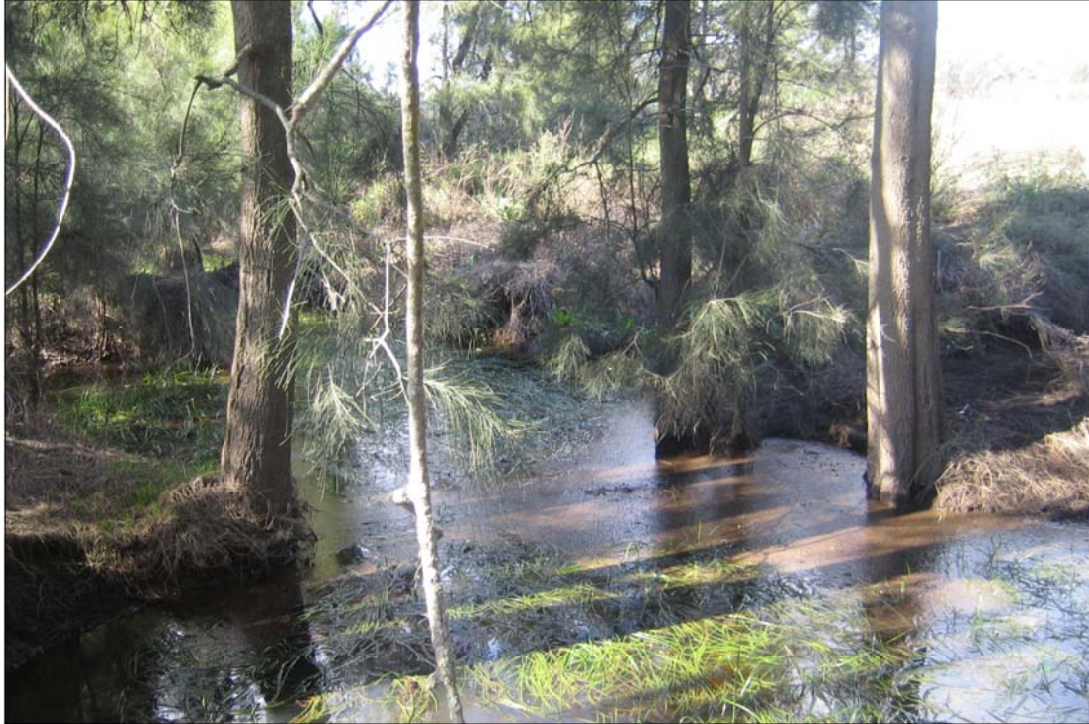
PLATE 5
Site 4 Bearing 135 Autumn 2008

The results of the Condition Assessment for both autumn and spring 2008 are provided in **Appendix 4**. As previously described in **Section 3.3.1**, the vegetation at Site 4 is highly modified, and is currently impacted by grazing. The native flora species diversity is very low, in both the mid and the lower strata.

There is no evidence of canopy dieback at this location. There is limited evidence of erosion along the bank, however slight undercutting was observed.

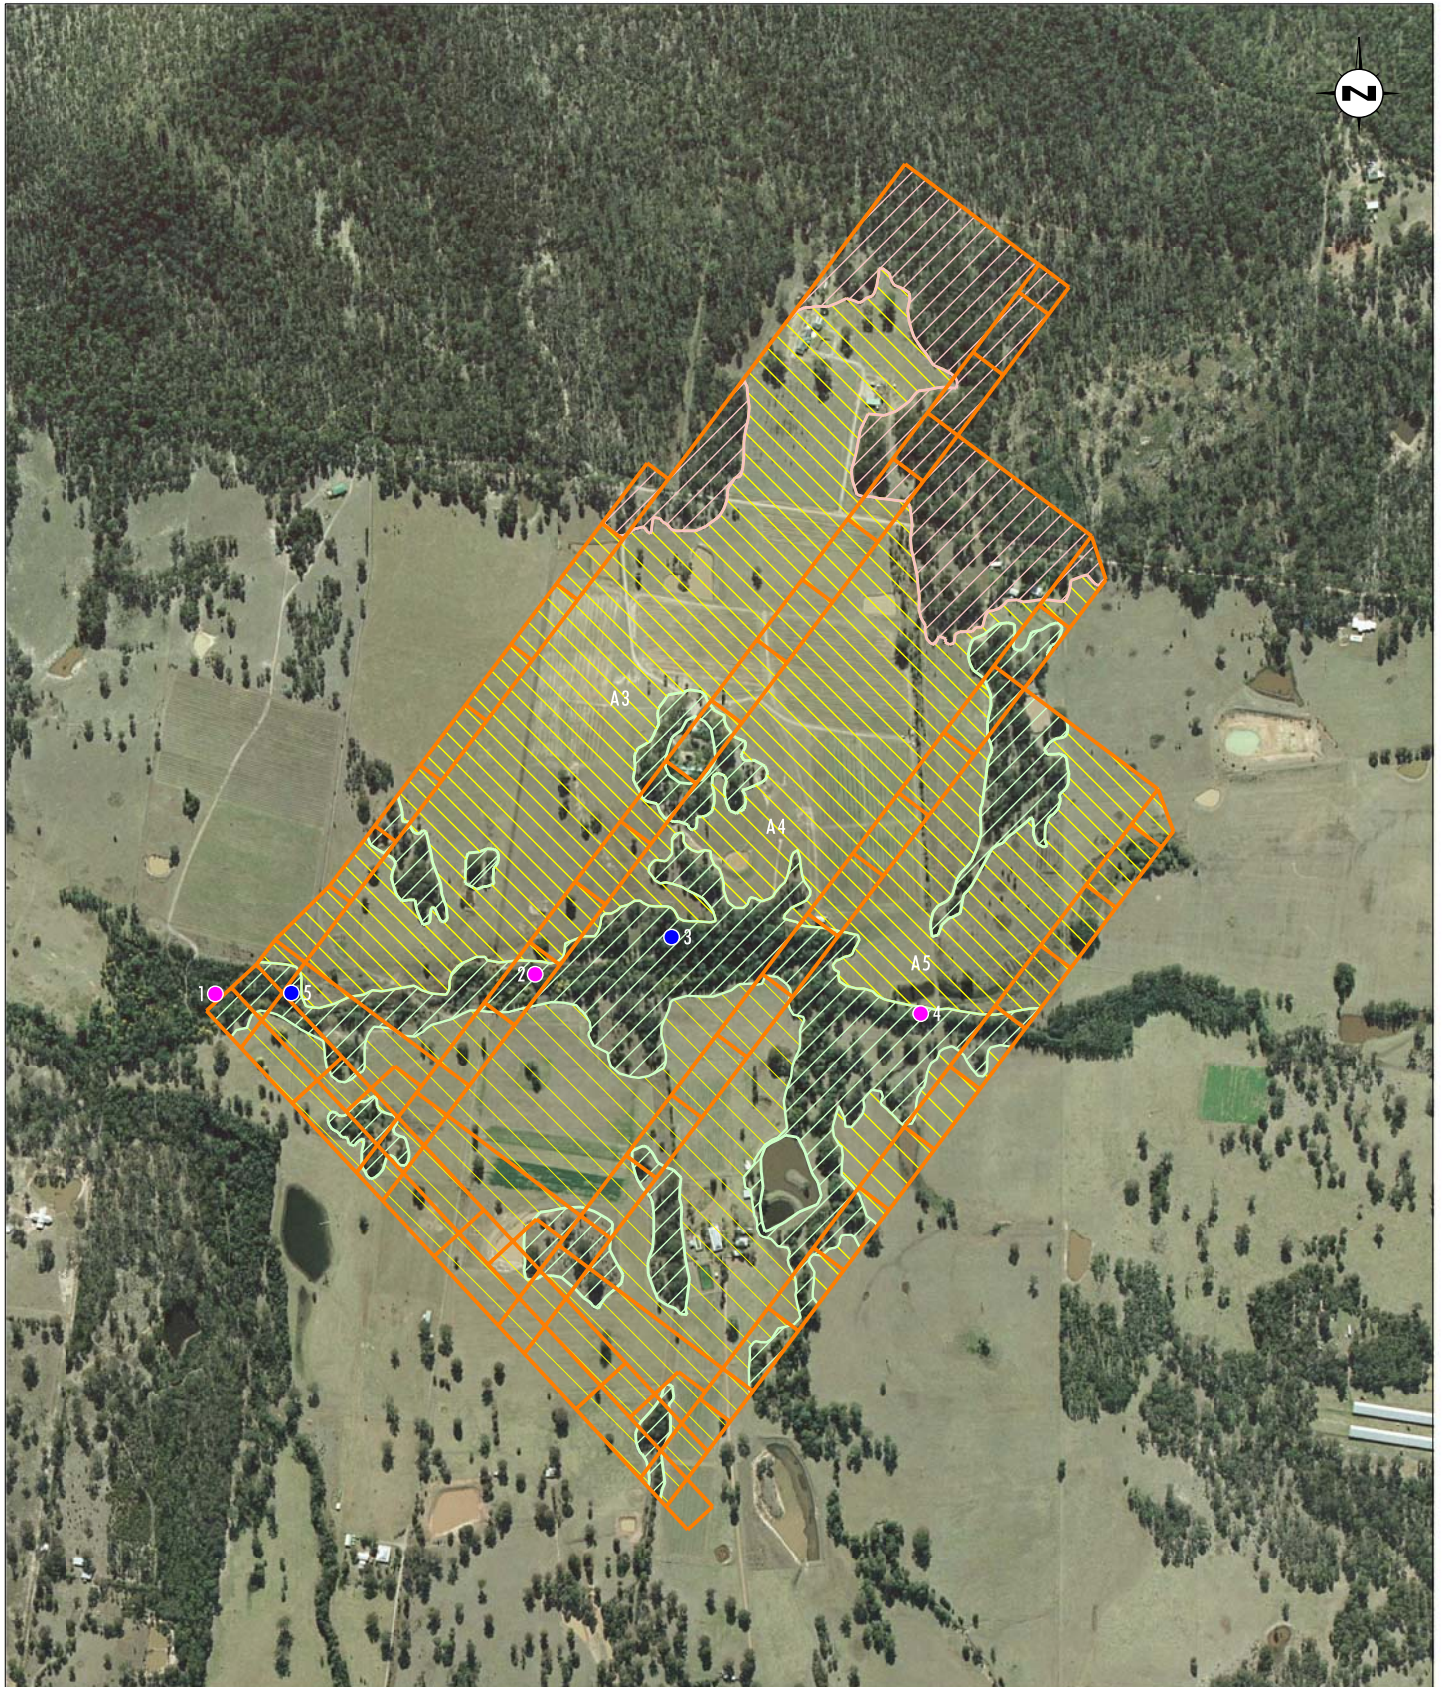
FIGURE 4.1

While the current monitoring sites provide a good representation of the Study Area, it was determined that the scope of the monitoring surveys could be expanded without significantly adding to the monitoring survey time. In particular, additional photo monitoring sites would provide greater coverage of the creek lines to identify changes that may be associated with subsidence. This is proposed through the addition of three new monitoring sites, the approximate locations of which are indicated on **Figure 4.1**. These sites are proposed to be incorporated into the next round of monitoring. A replacement Site 3 is proposed as an additional vegetation plot, while an additional Site 5 is proposed and will be similar to Site 4 where only a condition assessment and photo monitoring is undertaken.

Location of Proposed
Additional Monitoring Sites

Over time, additional photo monitoring points may be established at other locations within the Stage 2 Mining Area, in particular to monitor any changes to creek geomorphology. Any additional photo monitoring points established should be permanently marked with a labelled, metal stake or another suitable method agreed to with the landholder.
