END OF PANEL REPORT- STAGE 2 LONGWALL A5a

Austar Coal Mine Pty Ltd (Austar) completed extraction of Longwall A5a on 18 February 2013. Austar submits this End of Panel report for Longwall A5a in accordance with Condition 18 of Subsidence Management Plan (SMP) Approval for Austar Coal Mine Longwall A5a (File No. 10/22, approved on 27 April 2011).

1.0 INTRODUCTION	4
1.1. Background	4
1.2. Mining Geometry	4
2.0 COMPARISONS BETWEEN THE OBSERVED AND PREDICTED SUBSIDENCE MOVEMENTS	5
2.1. Introduction	5
2.2. Line A3	5
2.3. Line A3X	6
2.4. Line A4	7
2.5. Line A5a	8
2.6. Summary	9
APPENDIX A. FIGURES	10
APPENDIX B. DRAWINGS	11

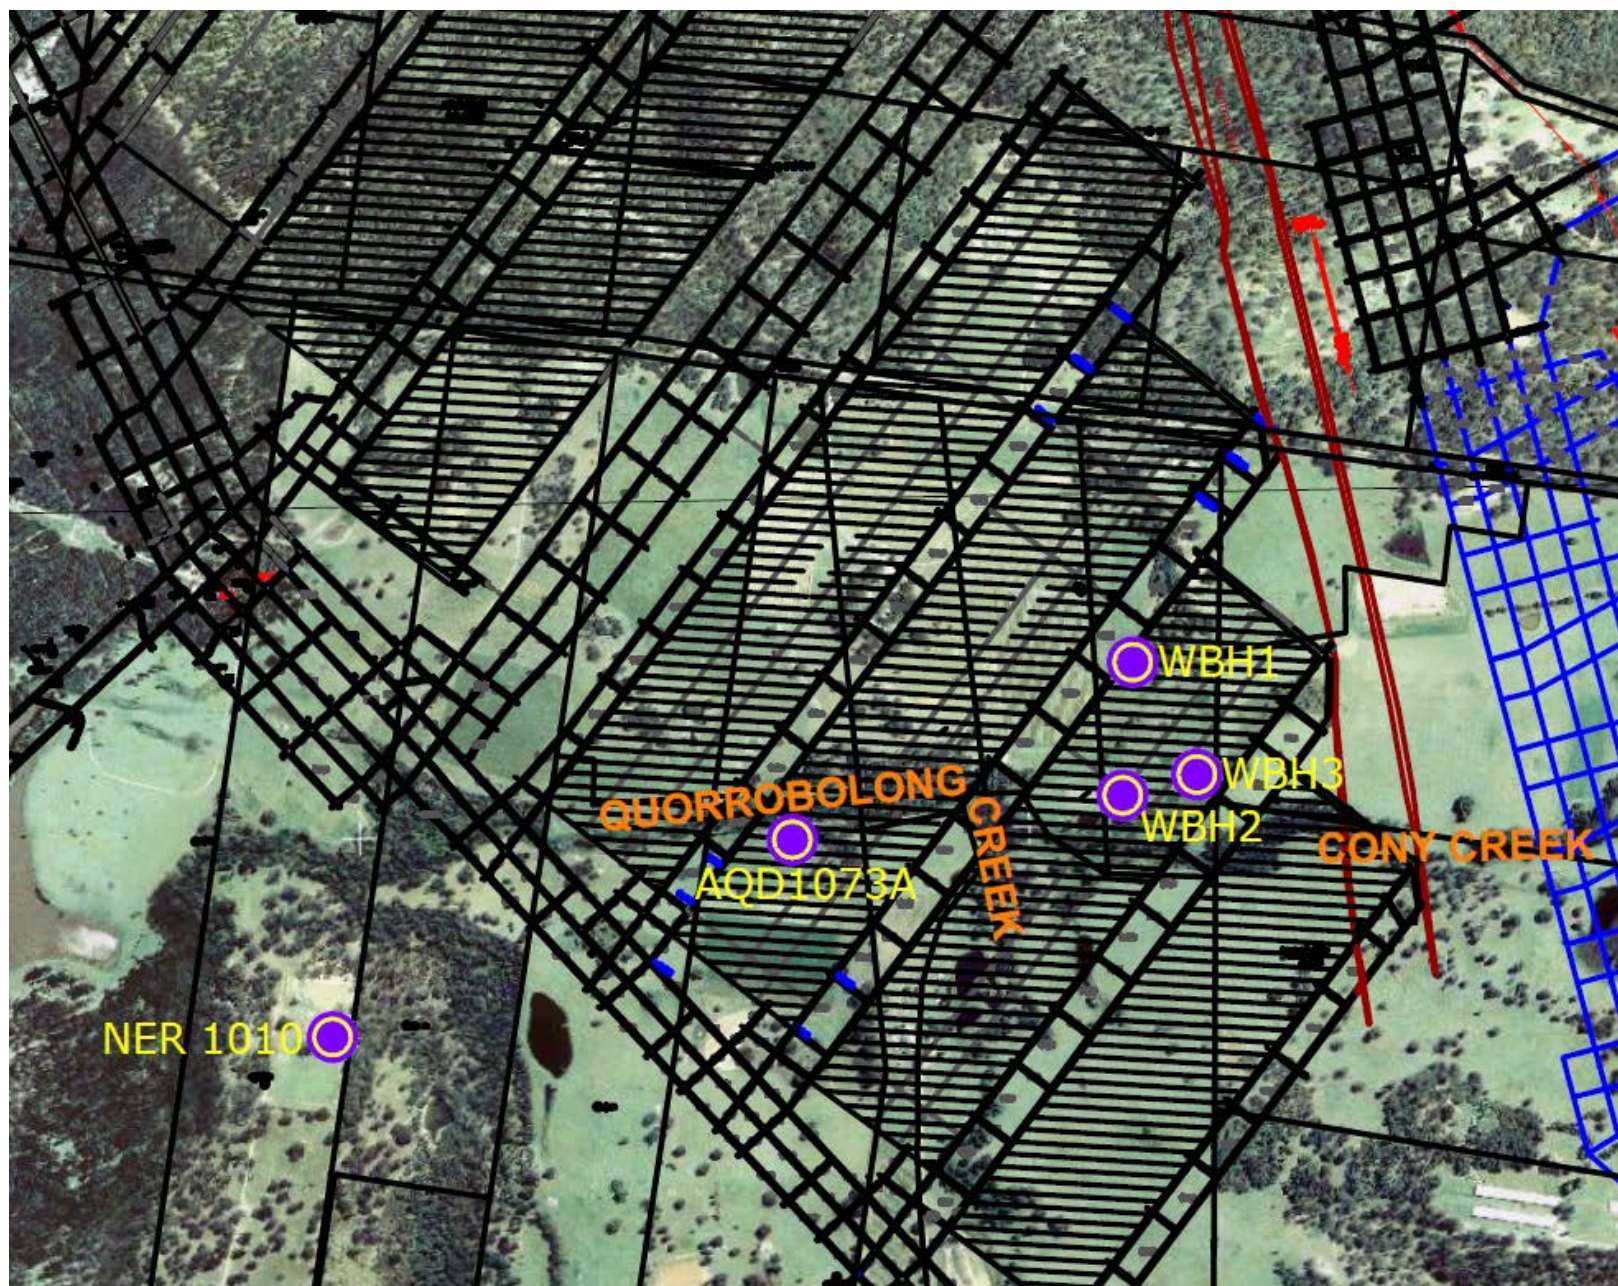
Figure 4.2 Austar Groundwater Monitoring Network

Groundwater monitoring continued in established alluvial monitoring wells AQD1073a, WBH1, WBH2 and WBH3, and in the sandstone water bearing zone in the Branxton formation in monitoring well NER1010 during longwall extraction of A5a.

Water level monitoring results are presented with rainfall data in **Figure 4.1** for the monitoring period April 2012 to May 2013. The location of groundwater monitoring wells is shown in **Figure 4.2**.
