Austar Coal Mine

LWB1, LWB2 & LWB3 Extraction Plan / Subsidence Risk Assessment

Final Report

March 2016

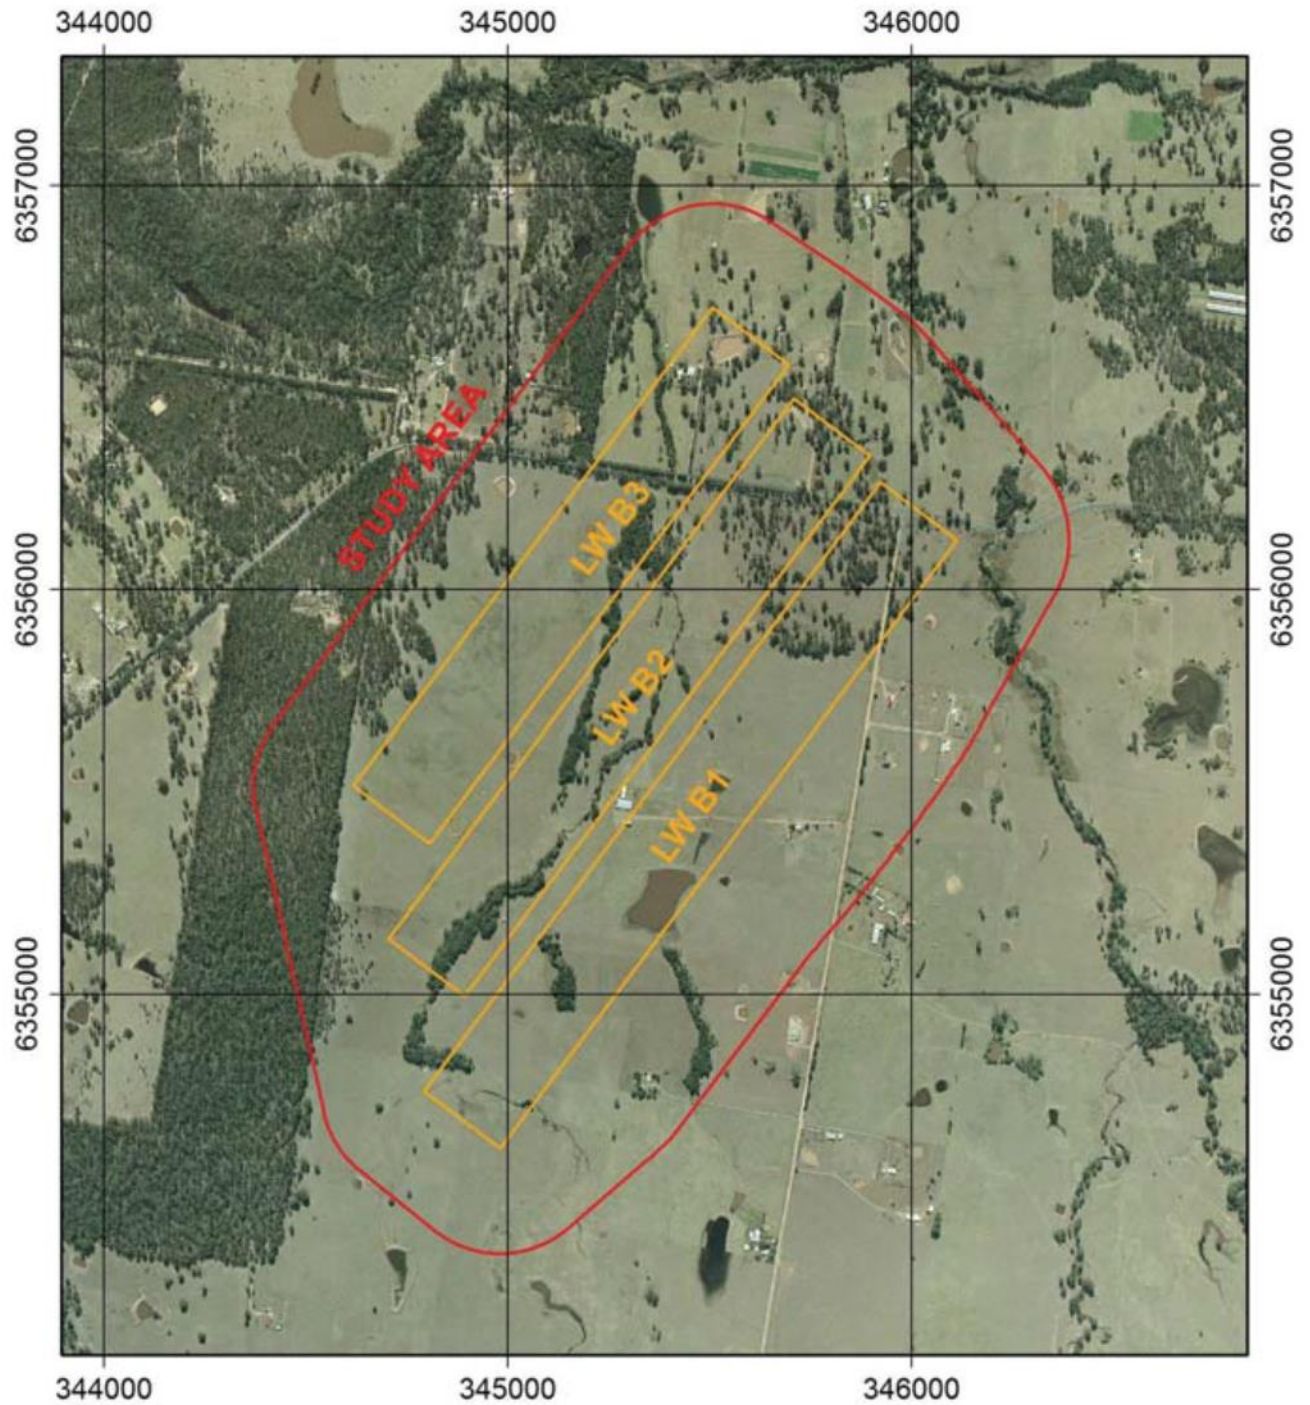
Figure 1 – Austar Extraction Plan Area LWB1 to LWB3.

The Austar Extraction Plan Area for longwall panels LWB1 to LWB3 is shown below in *Figure 1 – Austar Extraction Plan Area LWB1 to LWB3*. The study area is bounded by a 26.5 degree angle of draw from the extremities of the longwall panels and is delineated by a red line

The physical scope of this extraction and subsidence risk assessment is delineated by a red outline in *Figure 1 – Austar Extraction Plan Area LWB1 to LWB3*, an area of approximately 314ha, located in Quorrobolong, approximately 3kms east of the township of Ellalong, in the lower Hunter Valley, NSW.

This risk assessment was limited to the Extraction Plan Area as defined in *Figure 1 – Austar Coal Mine Extraction Plan Area for longwalls LWB1 to LWB3*.
