Austar Coal Mine

LWB4 to LWB7 Extraction Plan / Subsidence Risk Assessment

Final Report

HMS1379

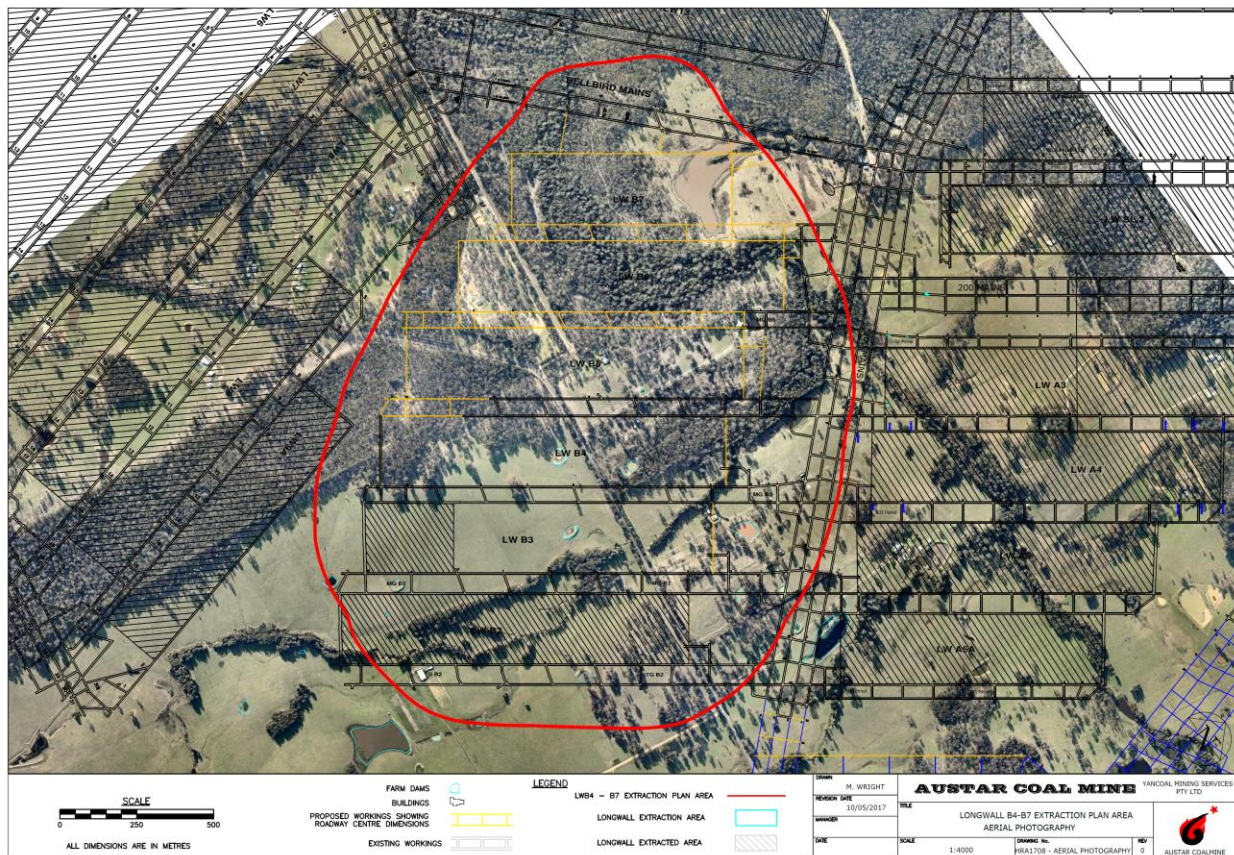
Figure 1 – Austar Extraction Plan Area LWB4 to LWB7.

The Austar Extraction Plan Area for longwall panels LWB4 to LWB7 is shown below in *Figure 1 – Austar Extraction Plan Area LWB4 to LWB7*. The study area is bounded by the predicted 20mm subsidence contour that may occur after extraction of longwall panels LWB4 to LWB7 as is delineated by the red line on Figure 1.

The physical scope of this extraction and subsidence risk assessment is delineated by a red outline in *Figure 1 – Austar Extraction Plan Area LWB4 to LWB7*, an area of 288ha, located in Quorrobolong, approximately 3kms east of the township of Ellalong, in the lower Hunter Valley, NSW.

This risk assessment was limited to the Extraction Plan Area as defined in *Figure 1 – Austar Coal Mine Extraction Plan Area for longwalls LWB4 to LWB7*.
